**Total Land Subsidence in the Butler Valley Area, La Paz County**  
**Based on Radarsat-2 Satellite Interferometric Synthetic Aperture Radar (InSAR) Data**  
**Time Period of Analysis: 1.0 Years 03/04/2021 To 04/16/2022**

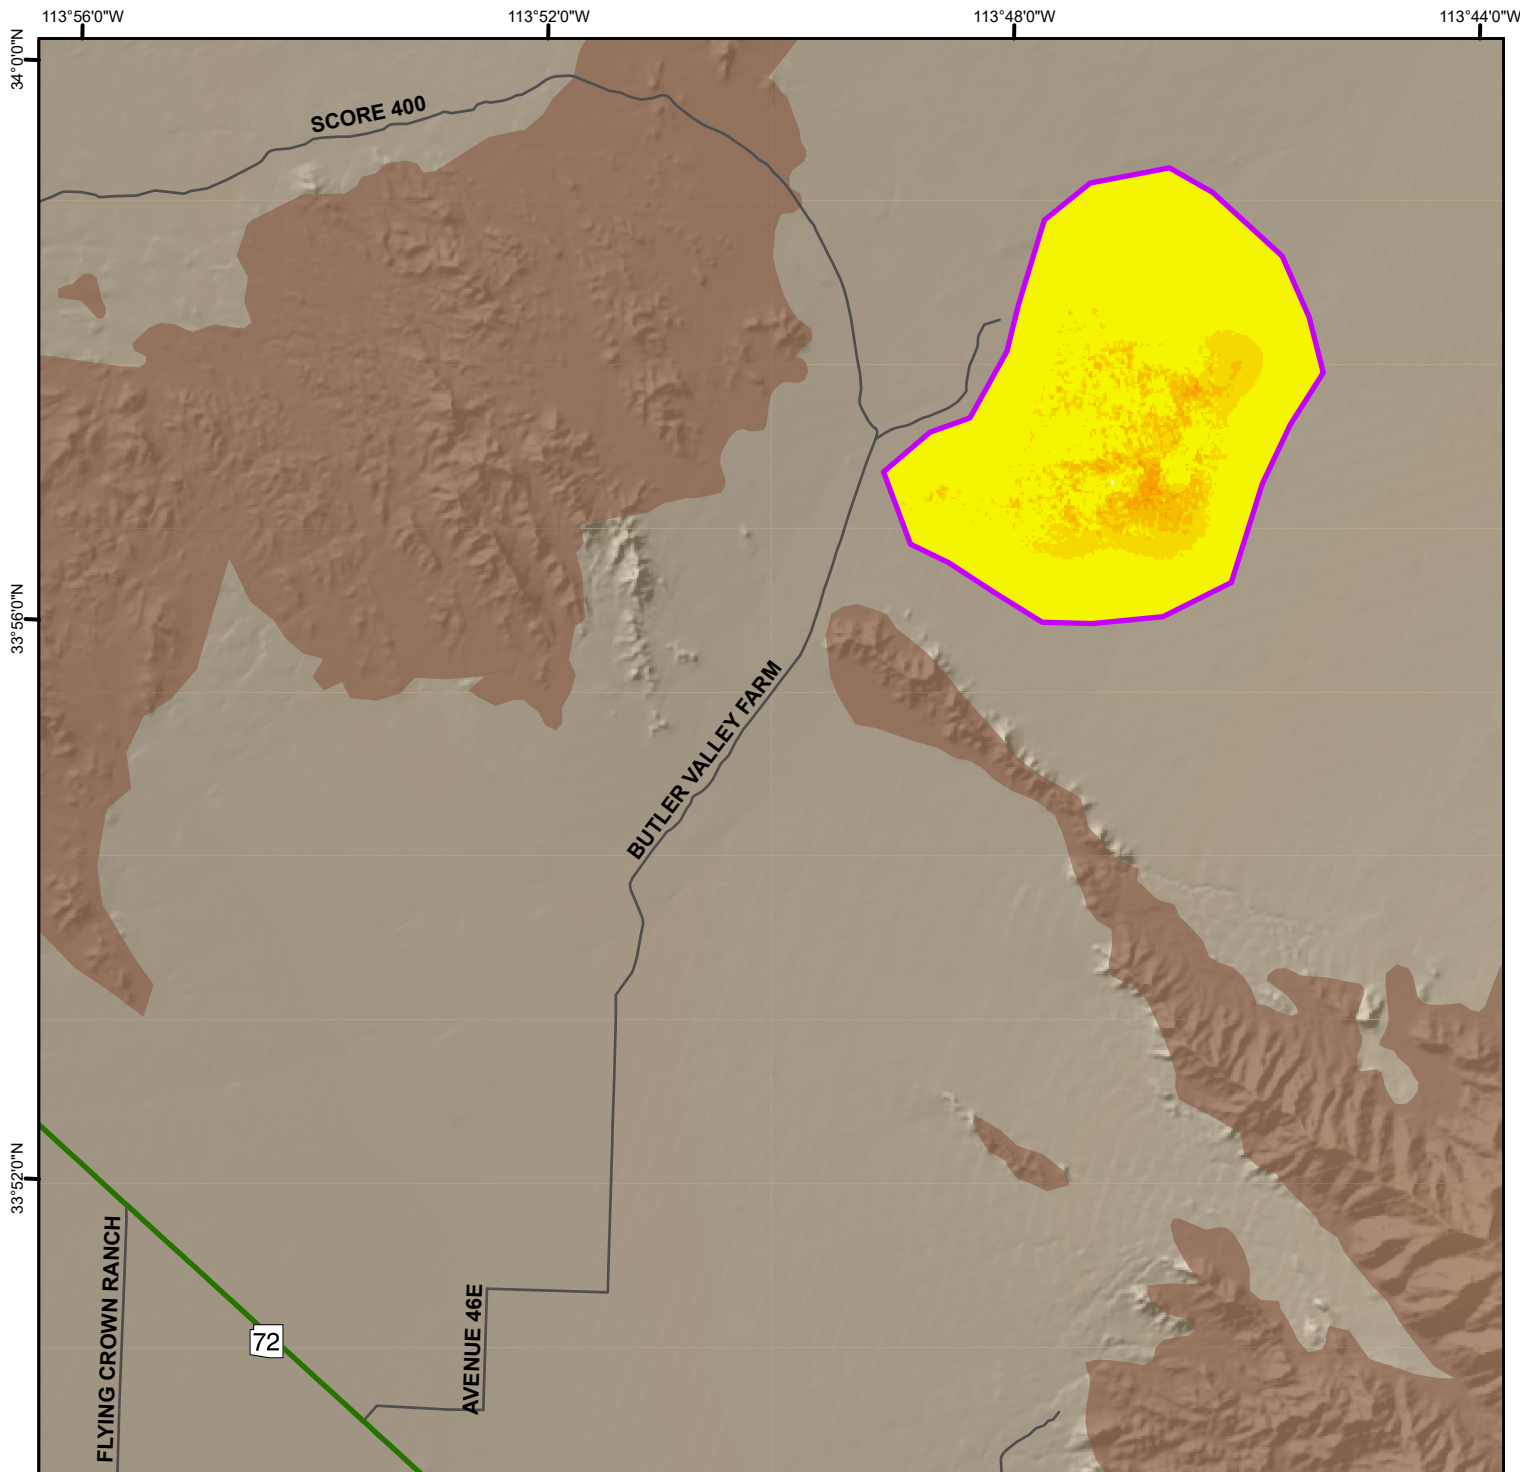
Decorrelation (white areas) are areas where the phase of the received satellite signal changed between satellite passes, causing the data to be unusable. This occurs in areas where the land surface has been disturbed (i.e. bodies of water, snow, agriculture areas, areas of development, etc).
